SUPPLEMENTARY MATERIAL

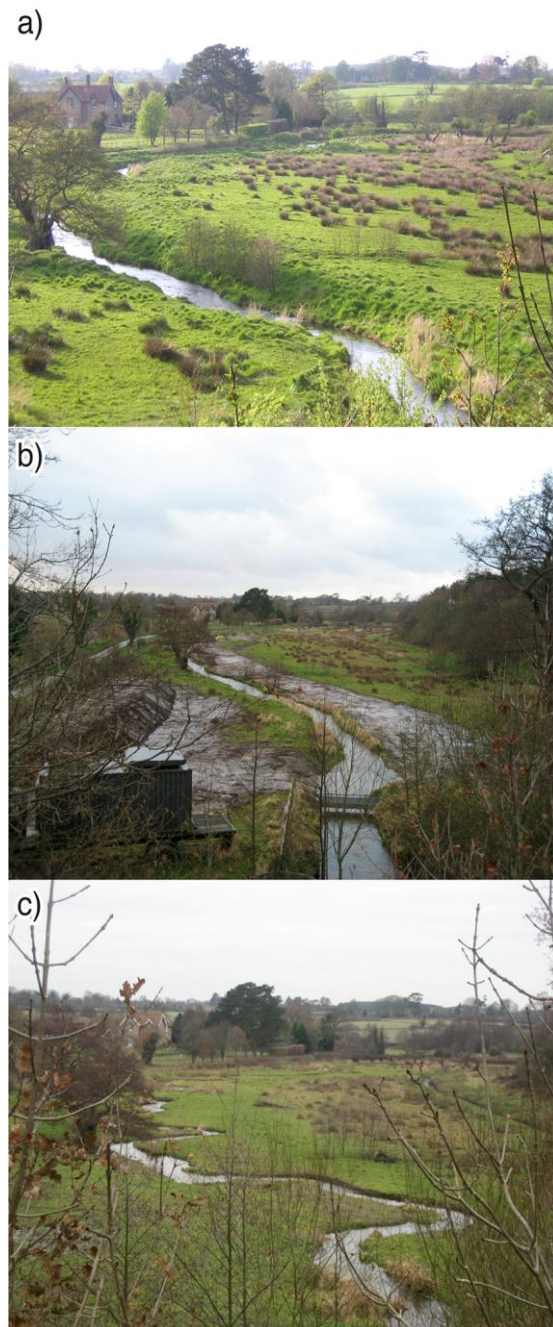
Fig. S1. Restoration reach of the River Glaven at Hunworth (north Norfolk, UK): (a) in January 2009, prior to the renaturation project; (b) after removal of embankments in March 2009; and (c) in December 2010, after recreation of meanders in August.

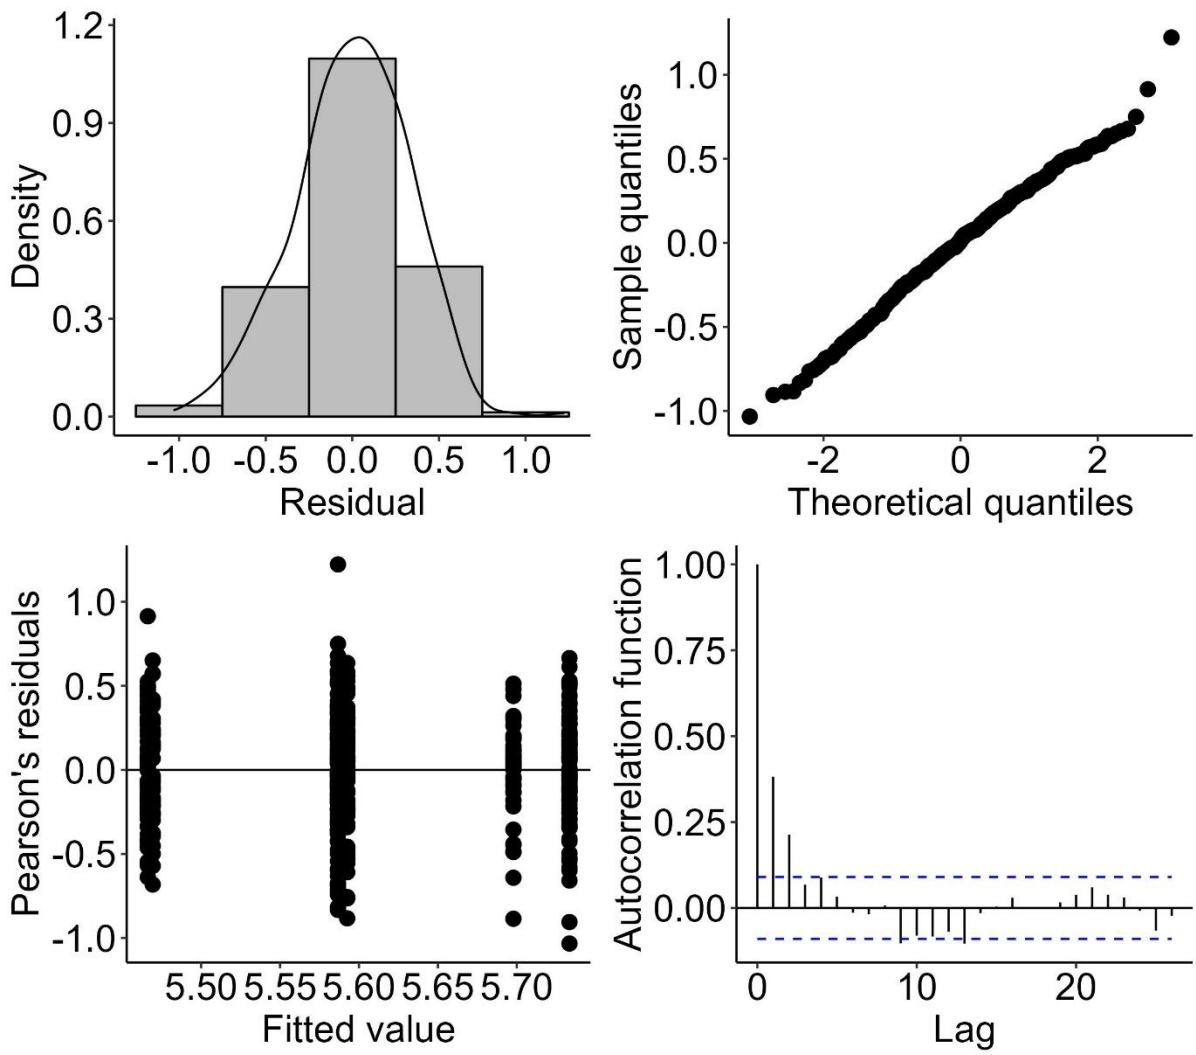
Fig. S5. Diagnostic plots suggesting that the assumptions of normally distributed, homoscedastic and independent residuals of linear model testing for effect of interaction of Site and Treatment on eel length were not severely violated.

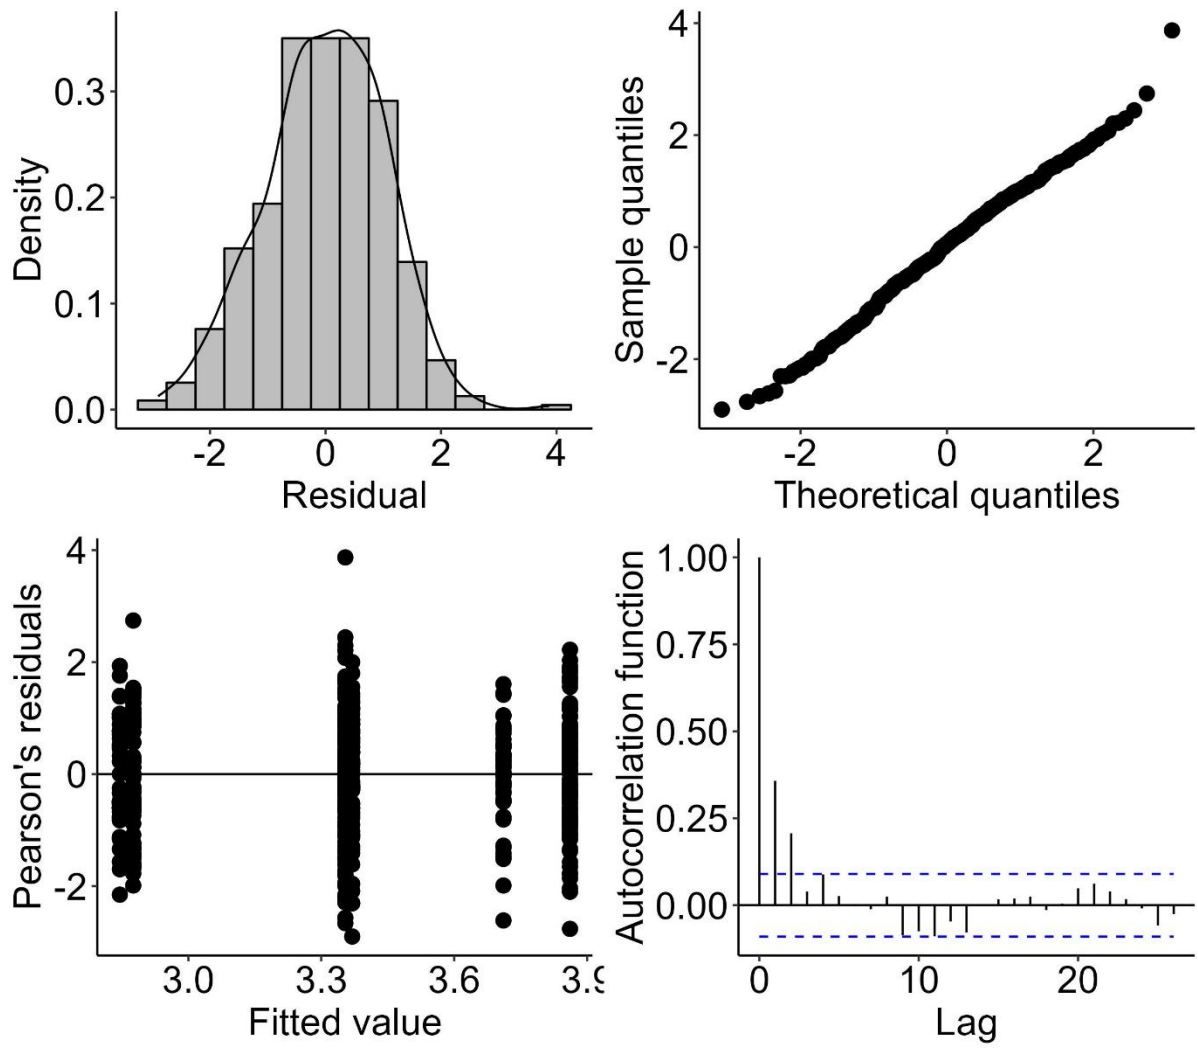
Fig. S6. Diagnostic plots suggesting that the assumptions of normally distributed, homoscedastic and independent residuals of linear model testing for effect of interaction of Site and Treatment on eel weight were not severely violated.
